**DELAWARE RIVER BASIN  
TRIBUTARY TO BEAVER RUN, CHESTER COUNTY,**

**RODEBAUGH DAM**

**PHASE I INSPECTION REPORT  
NATIONAL DAM INSPECTION PROGRAM**

**MARCH 1981**

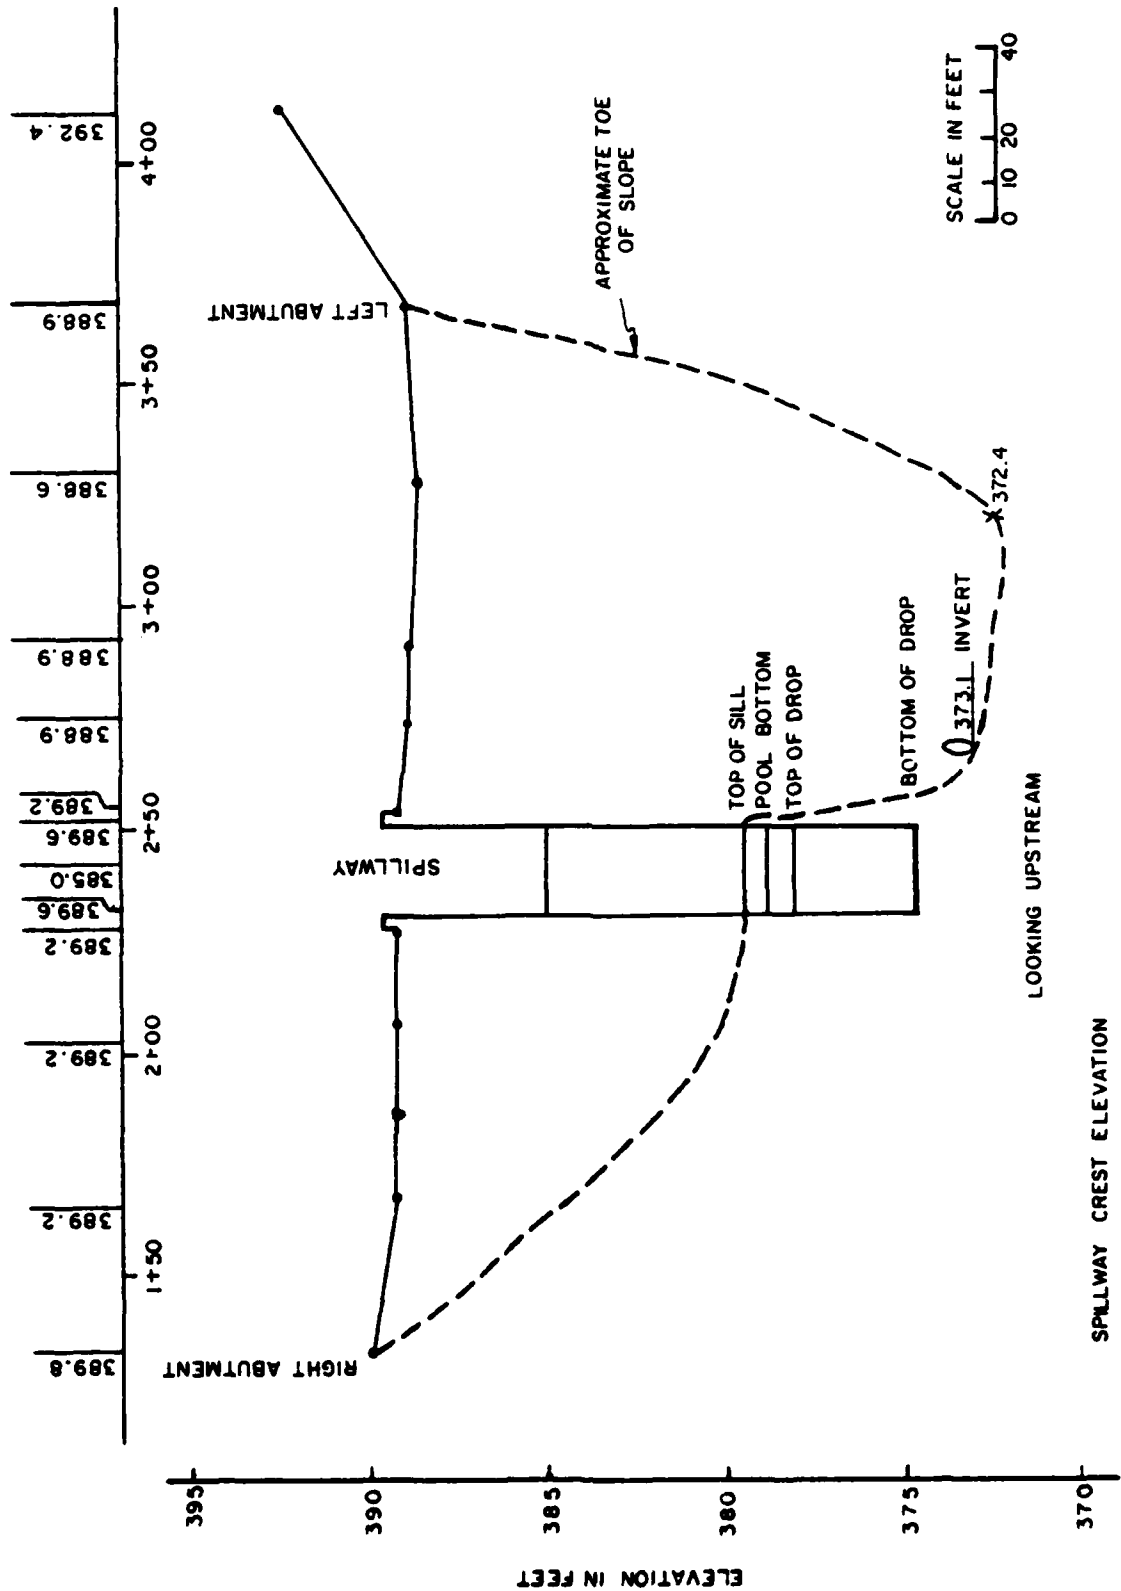
PROFILE ALONG CREST  
RODEBAUGH DAM  
SHEET 5B OF 11

b. Dam. The vertical alignment of the dam crest was checked and the profile is shown on Sheet 5B, Appendix A. There are no distortions in alignment that would be indicative of deep seated movement of the embankment or foundation although there are indications of surficial and/or shallow based movement of soils. Near the left spillway wall is a fresh transverse crack across the embankment crest about one-half inch wide. At the downstream edge of the embankment crest in the same location is a freshly disturbed area of soil removal and an area extending about six feet to the left of the spillway wall appears to have slumped, see Photograph 12 and Sheet 5A, Appendix A. About 40 feet left of the spillway and two feet below the downstream crest edge is a small scarp indicating downslope movement of soils or sod, see Photograph 9.
